# SAFETY BULLETIN

## MILITARY SEALIFT COMMAND

## Line Handling Incident

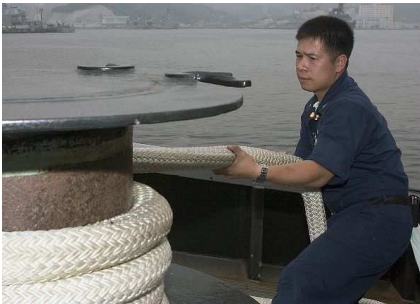
Fig 1

Answers for Page 2: Fig 1: When line handling jewelry and watches should be removed. Also consider use of Safety Glasses and hard hat. Fig 2: Too close to check, if something goes wrong body parts will be pulled right through check. Fig 3: Good use of PPE but individuals engaged in line handling need to focus on task at hand and not joke around.
